## TEST REPORT

No. : XMIN2503000372CM08\_EN

Sample Name : Topiary 6.0mm - Milliken Rigid Form LVT with attached cushion  
Product Specification : 6.0mm

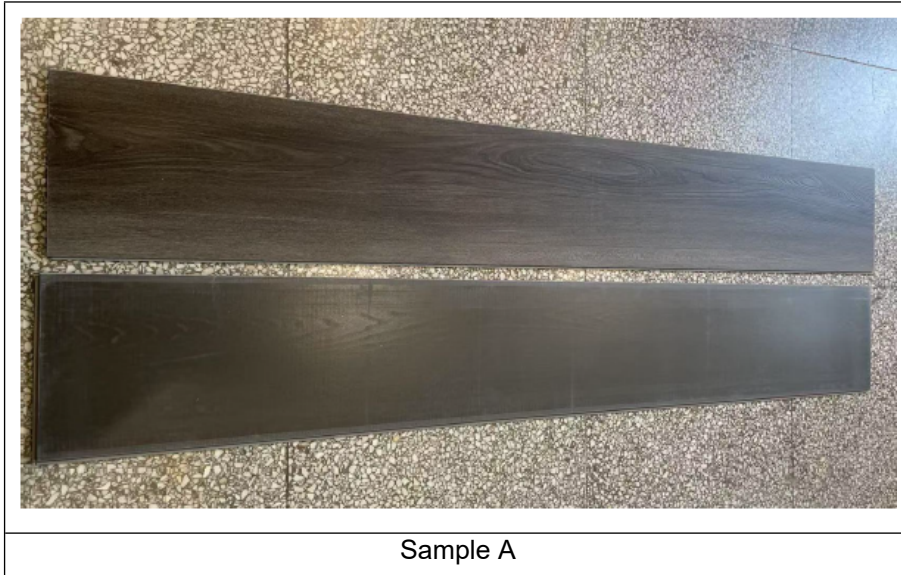
### Original Sample Photo:

Sample Description : Flooring (see the photo)  
Total thickness:6mm, surface density: about 10.2 kg/m<sup>2</sup>

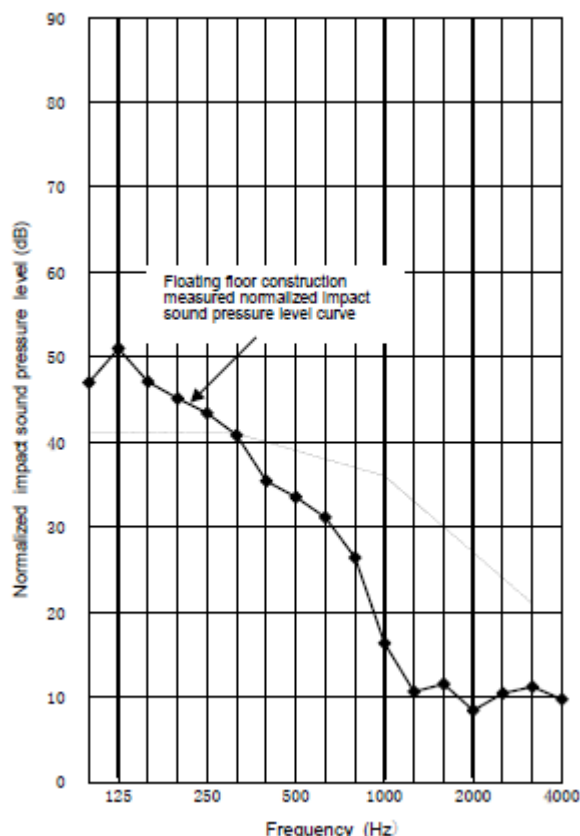
### Frequency spectrum

| <i>f</i><br>Hz | <i>L<sub>n</sub></i><br>dB |
|---|---|
| <i>L<sub>n,w</sub></i> = 39 dB; <i>C<sub>l,r</sub></i> =1 dB | |

Remark: *L<sub>n</sub>* as the weighted normalized impact sound pressure level

| No. | Test Item | Test Method | Result |
|---|---|---|---|
| 1 | Measurement of impact sound insulation | AS ISO 140.6-2006<br>AS ISO 717.2:2024 | $L_{n,w} = 39$ dB |

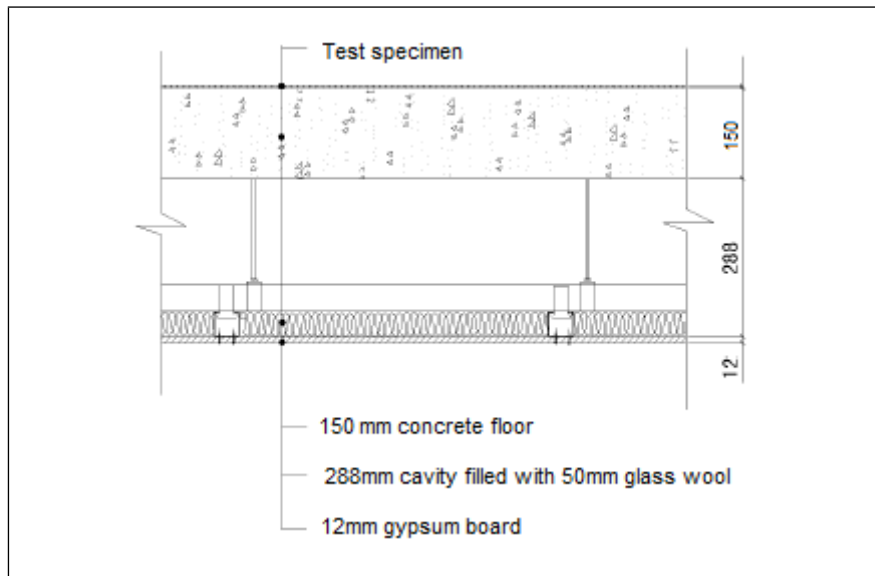
The constructional drawing of the floor/ceiling assembly system

Project description : No decoration of sample surface and installation assembled directly.  
The test specimen was covered on a 150mm concrete floor with a drop ceiling, testing area 11.3m<sup>2</sup>, the drop ceiling construction showed in following:  
Drop ceiling: 288mm cavity filled with 50mm glass wool, 12mm gypsum board.
